Making Better Impressions

A Troubleshooting Guide

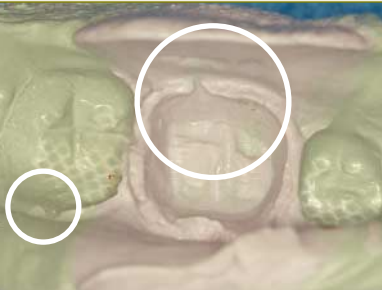
Visual Appearance
Incomplete margin.

Result Short crown margins and/or open margins.

Void caused by syringe technique

Keep syringe tip immersed while syringing.

Gently stir while syringing.

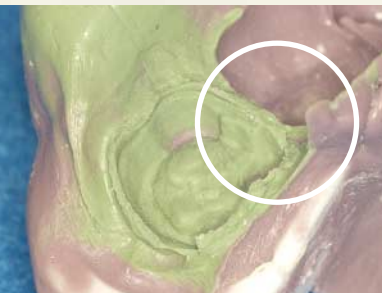
Air bubble on margin

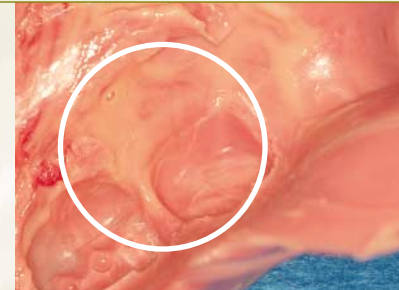
Visual Appearance
Non-homogeneous mix.

Result Slow setting
impression material.

Improper ratio of catalyst to base.

Mix tip not attached correctly.

Air in the 50ml cartridge.

"Streaky" inadequate mix

Bleed cartridge prior to attaching mix tip.

Use manufacturer's recommended mix tip.

Bleed cartridge to ensure equal catalyst/
base expulsion.
